Thorax artifacts in CT - air embolism or other causes?

Original article

Int. J. Radiat. Res., July 2021; 19(3): 653-659

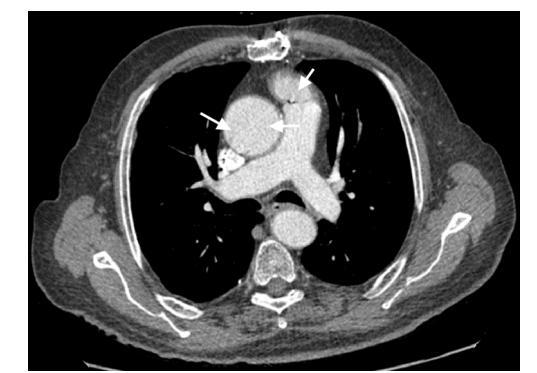
Figure 1. Axial image of thorax CT with contrast agent, which demonstrates an artifact with air density in the pulmonary trunk that imitates vessel rupture. This may have occurred from a false response of the reference detectors due to the existence of a small amount of contrast agent on the examination table of the CT scanner (upper right arrow). In addition, a streak artifact is present in the ascending aorta from the high contrast density in the adjacent superior vena cava.

More specifically, figure 1 illustrates an artifact with air density in the pulmonary trunk that imitates vessel rupture and a streak artifact in the ascending aorta from the high contrast density in the adjacent superior vena cava. Figure 2 shows a streak artifact caused by the wall calcifications of the ascending thoracic aorta. In figure 3, an artifact with air density in the pulmonary trunk is presented. In this case, the body of the patient was not entirely in the FOV. Figure 4 illustrate four artifacts with air density (in the cardiac muscle and on the top of the pulmonary vessels), which occurred in a case that no contrast agent was used. Finally, figure 4 demonstrates artifacts with air densities in the middle of the pulmonary vessels with the shape of undefined lines.

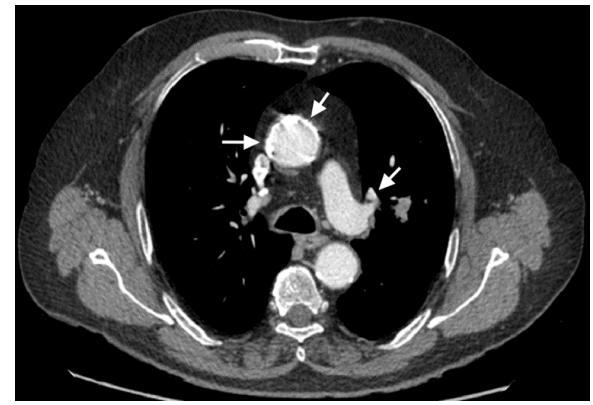
Figure 2. Axial image of thorax CT with contrast agent, which shows a streak artifact caused by the wall calcifications of the ascending thoracic aorta.

The present study proves that the causes of all the aforementioned artifacts are numerous. In fact, their most frequent form are streak artifacts. Although, the most common cause of those artifacts is the existence of metallic implants in the patient, there are other reasons too. For example, sometimes contrast agent may have so high density that mimics metal, so it creates streak artifacts especially near superior vena cava (figure 1) ^(7, 10-12, 14, 22-24). Also, more rarely, even wall calcifications of the thoracic vessels could mimic metal densities and create streak artifacts (figure 2).

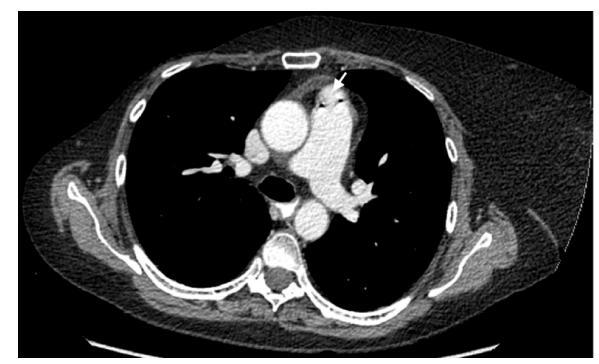
Figure 3. Axial image of thorax CT with contrast agent of an overweighed patient, which indicates an artifact with air density in the pulmonary trunk (not in the highest level). The body of the patient was not entirely in the FOV and the artifact may have been caused by a fault of the reference detectors.

or in overweight patients where the FOV is not large enough to cover the entire part of the body. In those cases, the reference detectors measure incorrectly and produce artifacts. Further, this artifact was also observed in cases where a small amount of contrast agent was shed on the examination table of the CT scanner after vein rupture during contrast injection (figure 3).

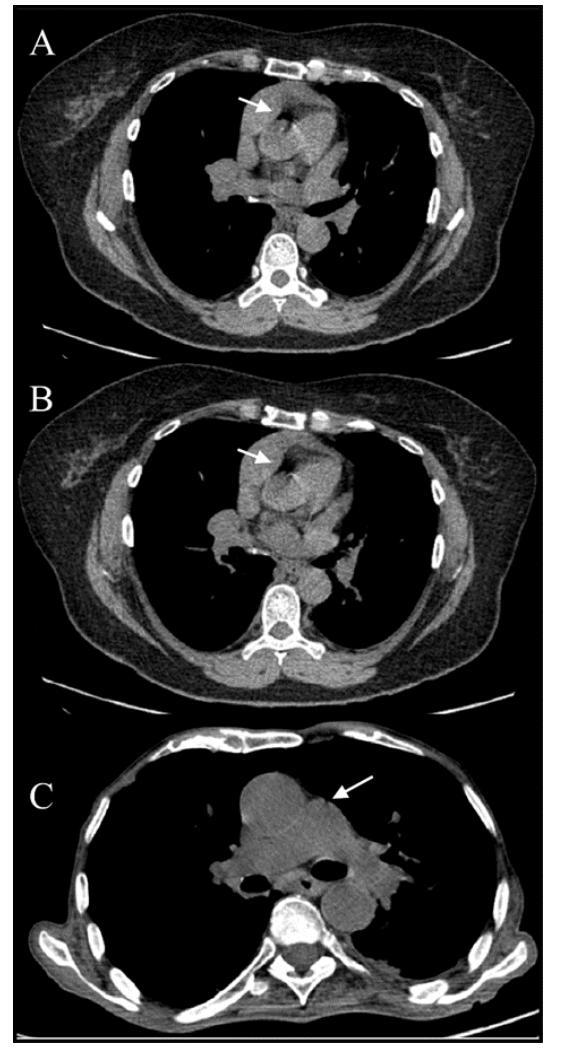
Figure 4. A-C. Axial images of thorax CT without contrast injection. Images **(A)** and **(B)** depict an artifact with air density in the cardiac muscle. Image **(C)** shows a small artifact with air density on the top of the pulmonary vessels. These artifacts may occur due to respiratory movements during scanning.

However, these artifacts are not commonly described in the literature despite their frequent appearance as air existence. In the present study, those artifacts were observed not only in cases involving contrast injection, but also in simple scans where no contrast was used. In those contrast agent-free scans, artifacts were caused by respiratory movements (figure 4).

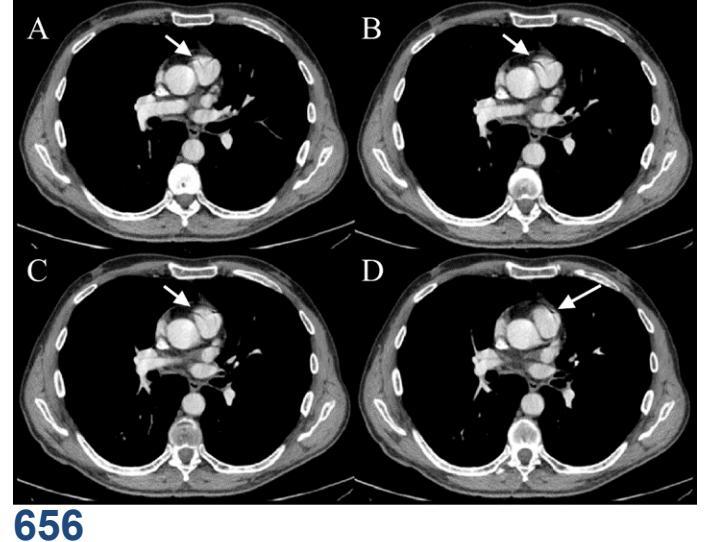
Figure 5. A-D. Axial consecutive images of thorax CT, which illustrate artifacts with air densities in the middle of the pulmonary vessels with the shape of undefined lines and they may be due to the existence of contrast agent on the examination table of the CT scanner.

Normally, every amount of air accumulates in the upper part of the anatomic structures. However, in this study, in some cases those artifacts appeared in the middle or lower sections of vessels in the form of lines and other long shapes. These findings indicate that those artifacts were not caused by the existence of air but instead due to the existence of an amount of contrast agent on the examination table of the CT scanner (figure 5).
